EXPERT REPORT
OF
DAVID J. ERICKSON

Community Association for Restoration of the Environment, Inc.
and Center for Food Safety, Inc.,

Cow Palace, LLC

(E.D. Wash. No. CV-13-3016-TOR)

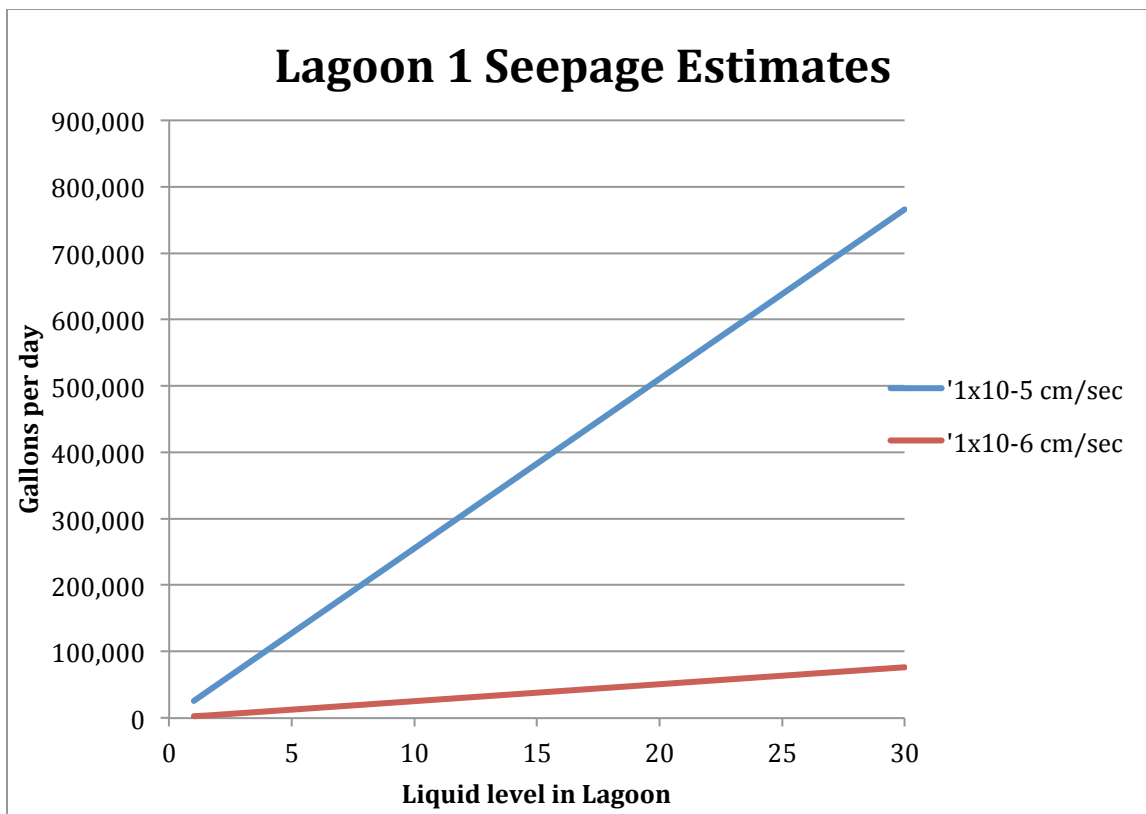
liner permeability between 1×10^{-5} cm/sec and 1×10^{-6} cm/sec while maintaining the lagoon under half full conditions, Lagoon 1 leaks between 38,298 and 383,000 gallons of manure-contaminated water per day, or 4.6 million to 46 million gallons per year, assuming that the pond is half full at least 4 months of the year. Even assuming a liner permeability of 1×10^{-7} cm/sec, Lagoon 1 leaks 3,830 gallons of manure-contaminated water per day, or 460,000 gallons per year, assuming the pond is half full at least 4 months of the year. Given, however, that the soil types in the area are of moderate to high permeability, that Cow Palace has not maintained its manure seal properly, and that Lagoon 1 was dug deeper to one side, the specific discharge amounts are likely on the high end of my calculations. The following graph provides seepage estimates for Lagoon 1 with respect to liquid level changes from 1' to 30' and a range of permeability between 1×10^{-5} cm/sec and 1×10^{-6} cm/sec.

54. The lagoon leakage is especially concerning with respect to ground water contamination issues. Once the seepage leaves the bottom of the lagoon it will infiltrate into the subsurface, saturate the underlying soil and continue to migrate in the subsurface until it encounters ground water. Because the leakage occurs below the influence of any plants, there is no chance for the nitrate to attenuate due to plant uptake.

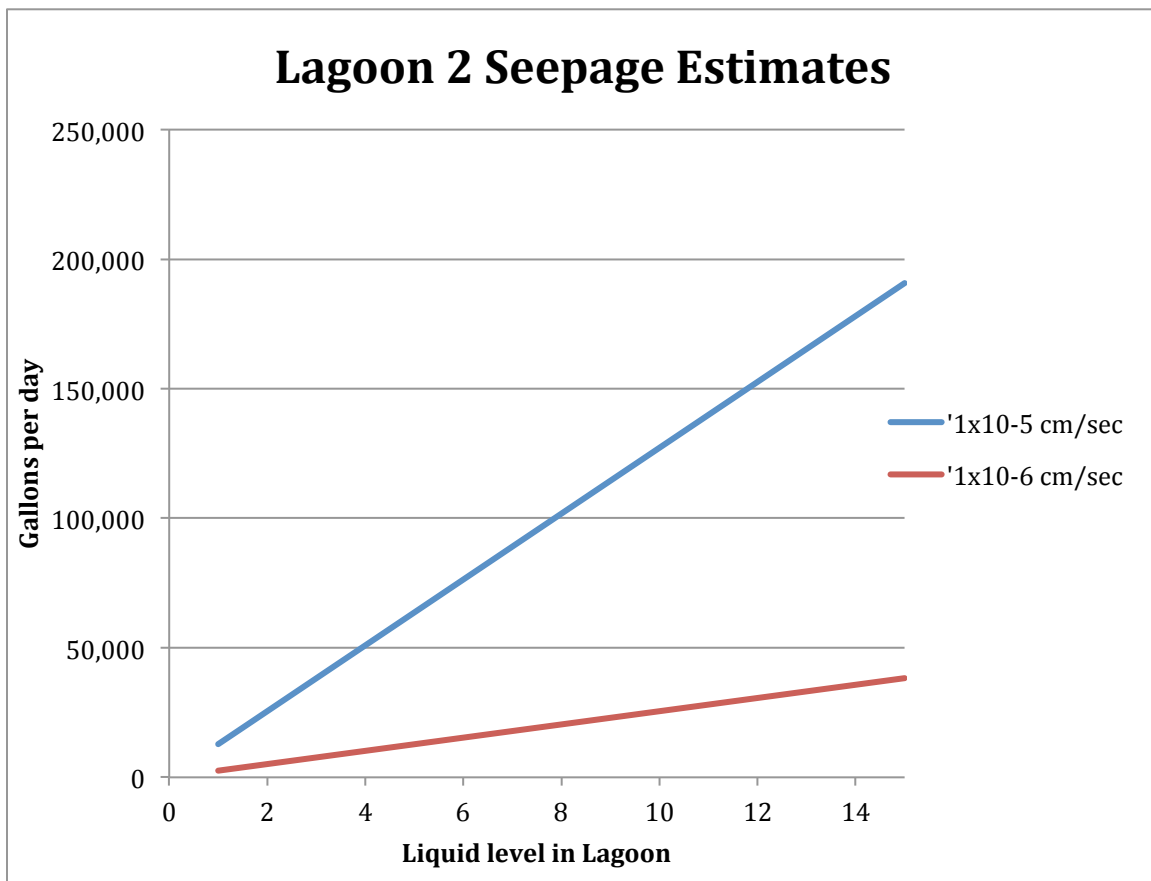
66. There is no question that Lagoon 2 leaks large amounts of liquid manure into the ground. The only variable in the equation that has not been directly tested is the in-place permeability of the liner. The other significant variable that changes over time is the depth of liquid in the lagoon which, in this equation, is equal to the head or pressure exerted on the liner. The variable ranges from 0 when the lagoon is empty to 15 feet when the lagoon is full; however, since this is the second lagoon in the process, it most likely contains liquid during about 6 months per year. Assuming that the lagoon has a soil liner that is one foot thick and varying the liner permeability between 1×10^{-5} cm/sec and 1×10^{-6} cm/sec while maintaining the lagoon under half full conditions, Lagoon 2 leaks between 9,543 and 95,400 gallons of manure-contaminated water per day, or 1.7 million to 17 million gallons per year, assuming that the pond is half full at least 6 months of the year. Even assuming a liner permeability of 1×10^{-7} cm/sec and half full 6 months of the year, Lagoon 2 leaks 954 gallons of manure-contaminated water per day, or 170,000 gallons per year. Given, however, that the soil types in the area are of moderate to high permeability, that Cow Palace has

not maintained its manure seal properly, the specific discharge amounts are likely on the high end of my calculations. The following graph provides seepage estimates for Lagoon 2 with respect to liquid level changes from 1' to 15' and a range of permeability between 1×10^{-5} cm/sec and 1×10^{-6} cm/sec.

67. The lagoon leakage is especially concerning with respect to ground water contamination issues. Once the seepage leaves the bottom of the lagoon it will infiltrate the subsurface, saturate the underlying soil and continue to migrate in the subsurface until it encounters ground water.

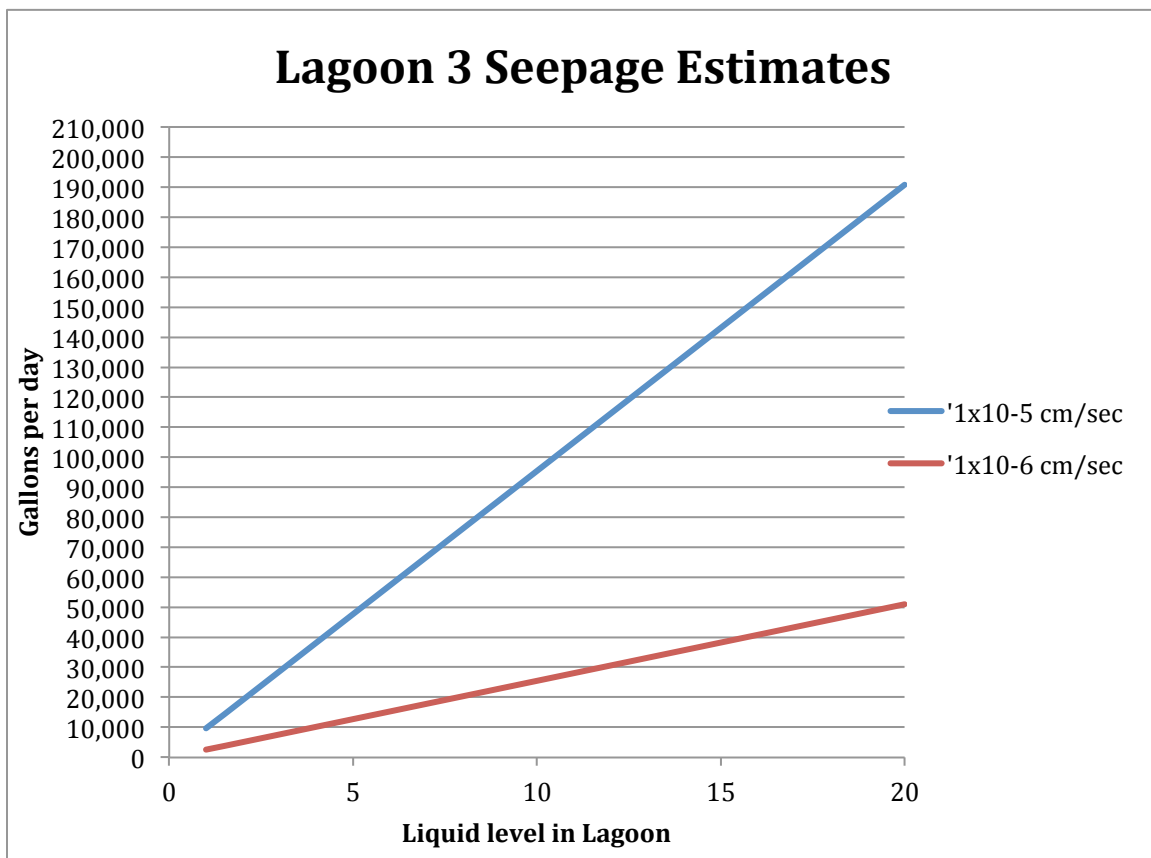
71. There is no question that Lagoon 3 leaks large amounts of liquid manure into the ground. The only variable in the equation that has not been directly tested is the in-place permeability of the liner. The other significant variable that changes over time is the depth of liquid in the lagoon which, in this equation, is equal to the head or pressure exerted on the liner. The variable ranges from 0 when the lagoon is empty to 20 feet when the lagoon is full; however, since this is the third lagoon in the process, it most likely contains liquid about 4 months per year. Assuming that the lagoon has a soil liner that is one foot thick and varying the liner permeability between 1×10^{-5} cm/sec and 1×10^{-6} cm/sec while maintaining the lagoon under only half-full conditions, Lagoon 3 leaks between 9,543 and 95,400 gallons of manure-contaminated water per day, or 1.16 million and 11.6 million gallons per year, assuming that the pond is half-full at least 4 months of the year. Even assuming a liner permeability of 1×10^{-7} cm/sec and half-full conditions

four months of the year, Lagoon 3 leaks 954 gallons of manure-contaminated water per day, or 116,000 gallons per year. Given, however, that the soil types in the area are of moderate to high permeability, that Cow Palace has not maintained its manure seal properly, the specific discharge amounts are likely on the high end of my calculations. The following graph provides seepage estimates for Lagoon 3 with respect to liquid level changes from 1' to 20' and a range of permeability between 1×10^{-5} cm/sec and 1×10^{-6} cm/sec.

The lagoon leakage is especially concerning with respect to ground water

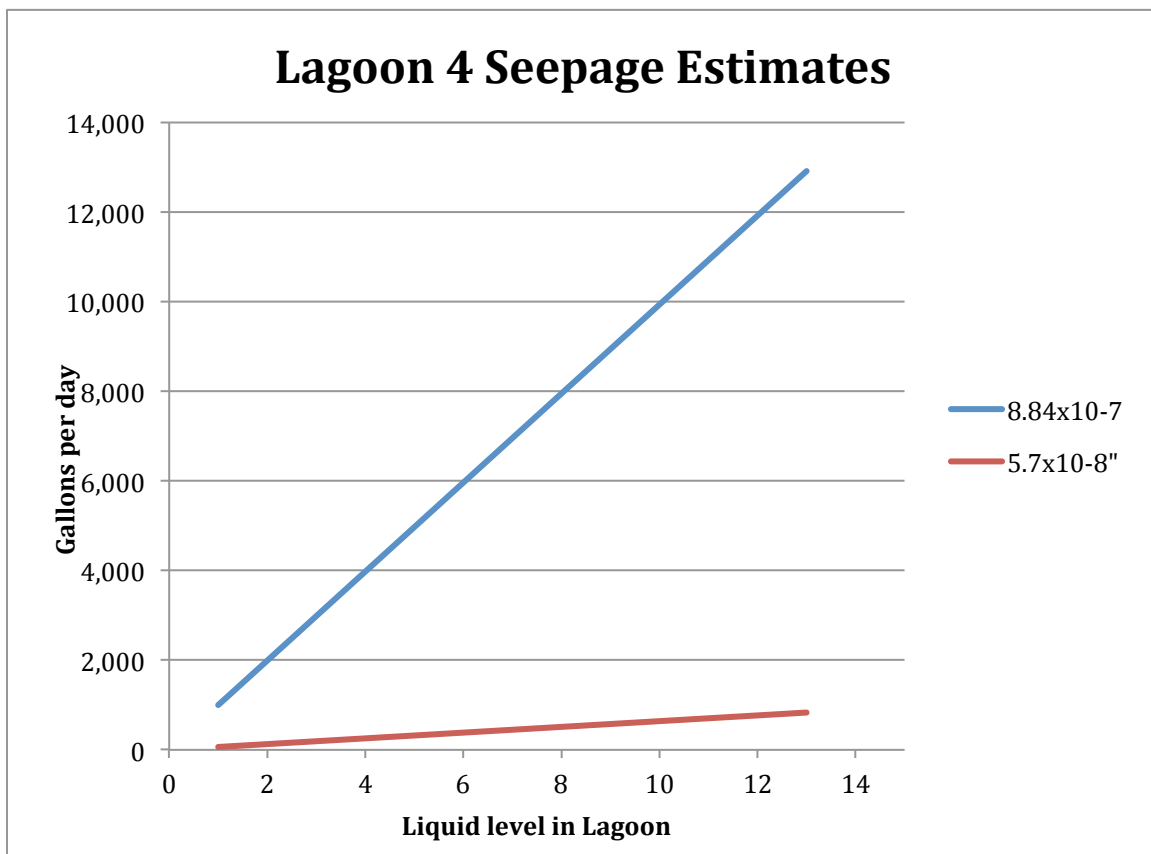
76. There is no question that Lagoon 4 leaks liquid manure into the ground. One variable in the equation that has not been directly tested is the in-place permeability of the liner with the manure seal, which may decrease the permeability by $\frac{1}{2}$ to 1 order of magnitude. The other significant variable that changes over time is the depth of liquid in the lagoon which, in this equation, is equal to the head or pressure exerted on the liner. The variable ranges from 0 when the lagoon is empty to 13 feet when the lagoon is full; however, since this is the fourth lagoon in the process, it most likely contains liquid during at least 4 months per year. Even assuming that the lagoon has a soil liner that is one foot thick and varying the liner permeability between 5.7×10^{-8} cm/sec and 8.84×10^{-7} cm/sec while maintaining the lagoon under half-full conditions, Lagoon 4 leaks between 416 and 6,458 gallons of

manure-contaminated water per day, or 50,600 to 785,000 gallons per year, assuming that the pond is half-full at least 4 months of the year. Given, however, that the soil types in the area are of moderate to high permeability, that Cow Palace has not maintained its manure seal properly, and liquids are likely in the pond more of the year, the specific discharge amounts are likely on the high end of my calculations. The following graph provides seepage estimates for Lagoon 4 with respect to liquid level changes from 1' to 13' and a range of permeability between 8.84×10^{-7} cm/sec and 5.7×10^{-8} cm/sec.

77. The lagoon leakage is especially concerning with respect to ground

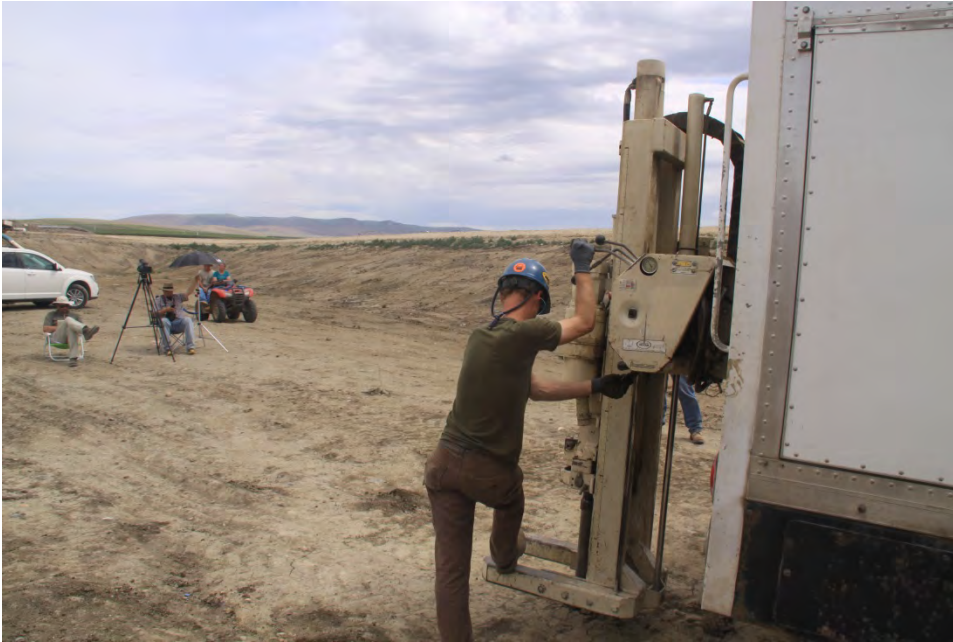
Photo. Collecting Geoprobe samples in the Bottom of Haak Lagoon

109. On May 23, 2014, I supervised the use of the Geoprobe hydraulic drill within Haak Dairy's large manure storage lagoon, which had been previously emptied some 7 months earlier in October 2013; mechanically excavated and scraped in November, 2013, which removed any type of "manure seal" that would have been present, and any other remaining solid manure; and then taken out of active service.

114. There were substantial concentrations of nitrate, phosphorus, and ammonium in the first foot underlying the Haak Lagoon. Nitrate was observed at 94.5 ppm, phosphorus at 69.7 ppm, and Ammonium at 750 ppm. This is highly indicative that liquid manure was seeping through the bottom of the Haak Lagoon.

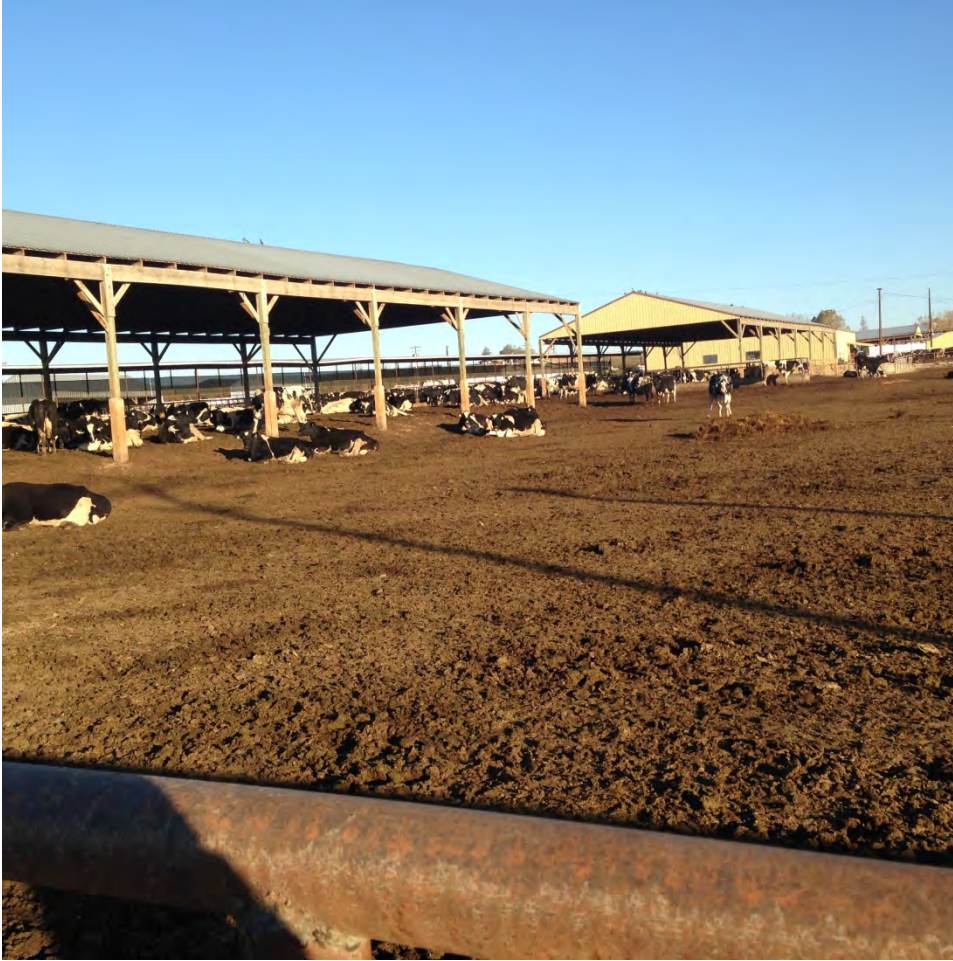
120. Another source of nitrate loading to groundwater is the Cow Palace's animal holding pens. I have personally observed the pens at Cow Palace twice, in October 2013 and in May 2014. Each time, I observed significant amounts of liquid manure, solid manure, and urine accumulated within the pens. The photographs below fairly depict the pens as I observed them in October 2013 and May 2014.

Photo. View to north-northwest of Cow Palace holding pen. Milking parlor visible in background.

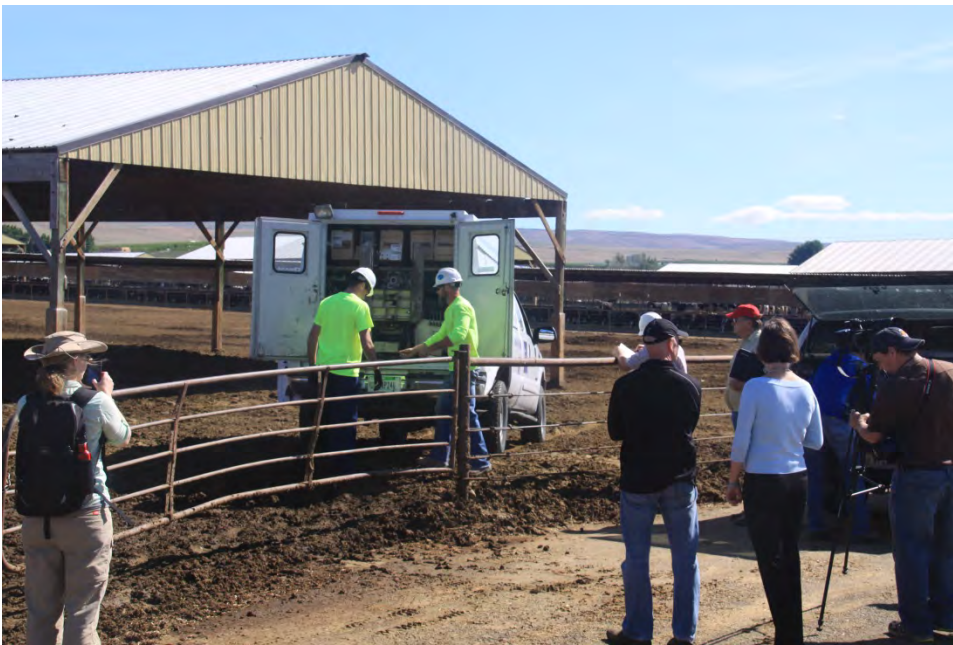
124. These results show that cow manure nutrients such as nitrogen and phosphorus have leached through the soils in Cow Palace's pens. The results from the first three feet of the boring CP-SB-10 are most telling. There, nitrate was observed in the 0-1 foot depth at 29.9 ppm; at the 1-2 foot depth at 94.9 ppm, and at the 2-3 foot depth at 92.1 ppm. Four feet down, there was 40 ppm nitrate observed in the soil.

Photo. Geoprobe boring in the Cow Palace Pens.

125. Similar to the lagoons, the data shows an aerobic conversion from ammonium to nitrate in the first 3 feet. The nitrate migrates in soil moisture under unsaturated conditions. When a permeable layer is encountered, the liquid can accumulate and flow along the flowpath to ground water. Since there is no vegetation in the pens, once the conversion to nitrate is complete,

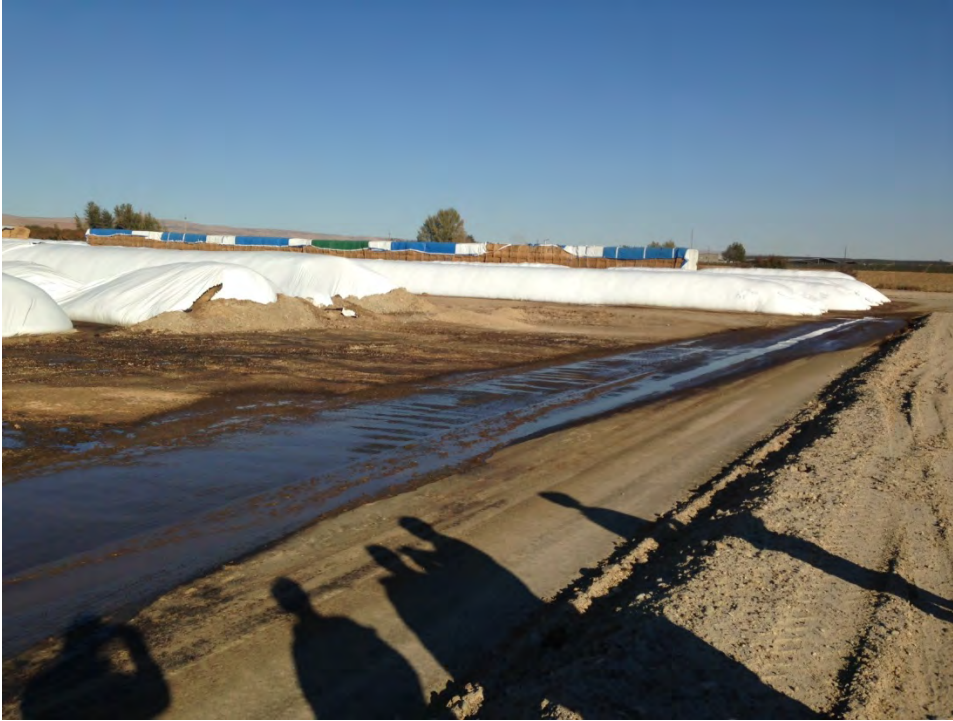
Photo. Silage Leachate

128. Given the concentration of nutrients in the acidic leachate from the silage and the fact that this liquid is allowed to run on and into the ground, additional measures should be taken to capture and handle the leachate properly.

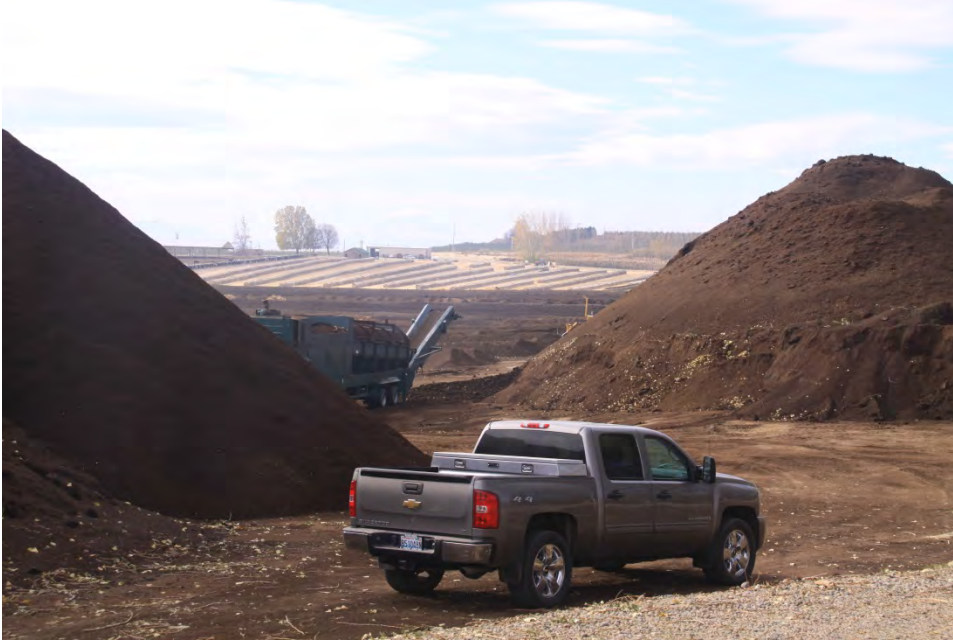
129. Another source of nitrate loading to groundwater is Cow Palace's composting area. I have personally observed the composting area at Cow Palace twice, in October 2013 and in May 2014. From my observations, solid manure is composted at Cow Palace on bare soil, without any concrete pads or other less permeable surfaces. The photographs below fairly depict the composting area as I observed it in October 2013 and May 2014.

Photo. Cow Palace compost processing area.

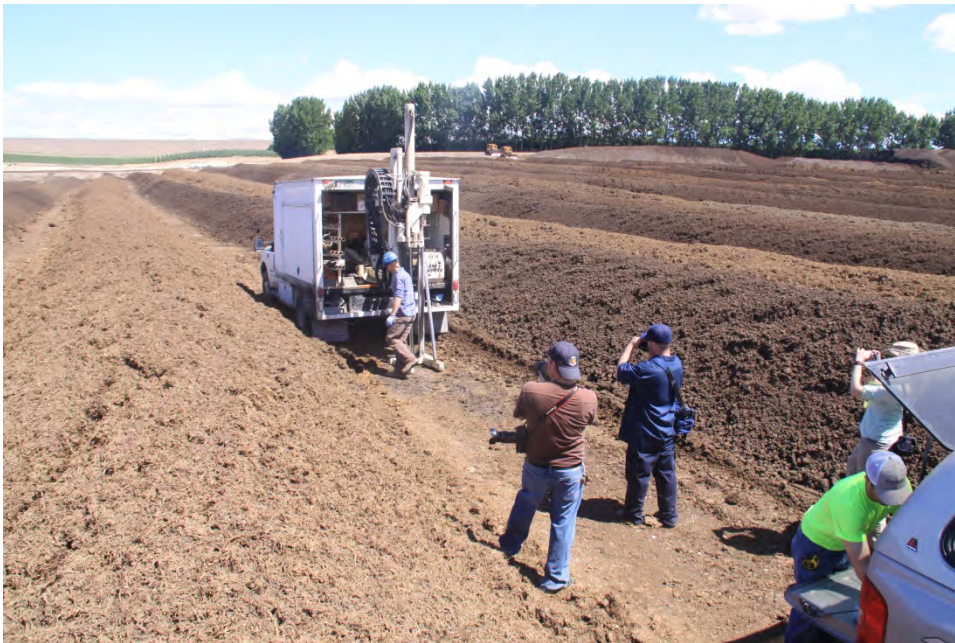
Photo. Soil sample collection in Compost Area.

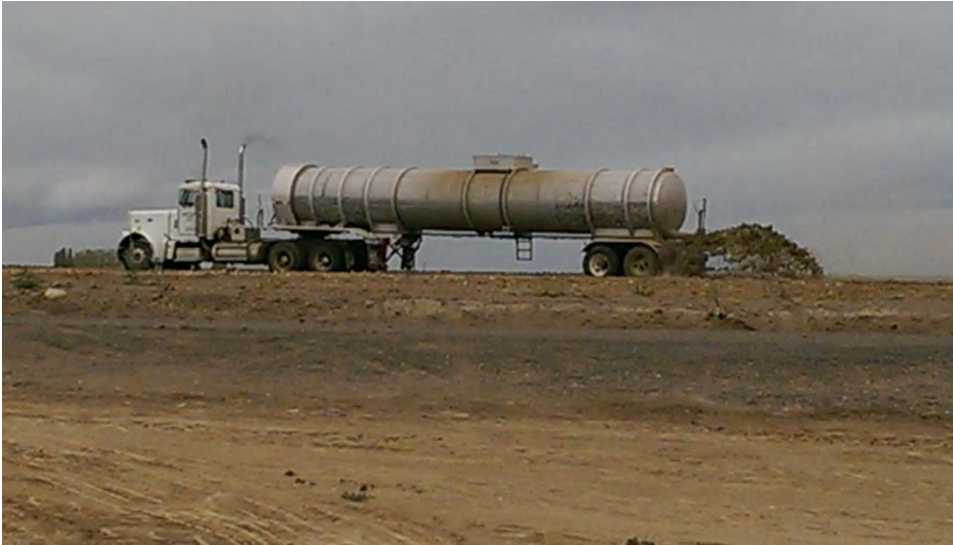
Photo. Manual application of liquid manure at Cow Palace.

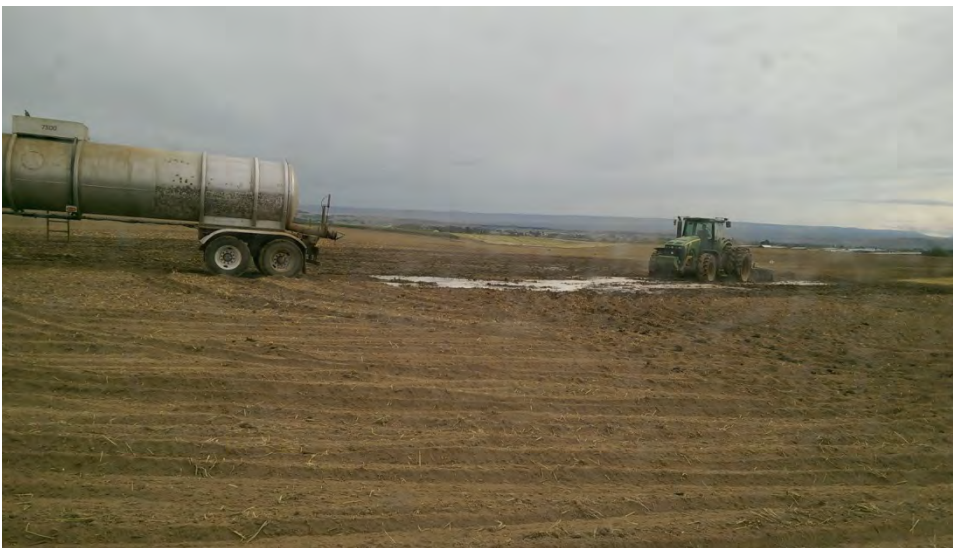
Photo. Liquid manure application and tilling.

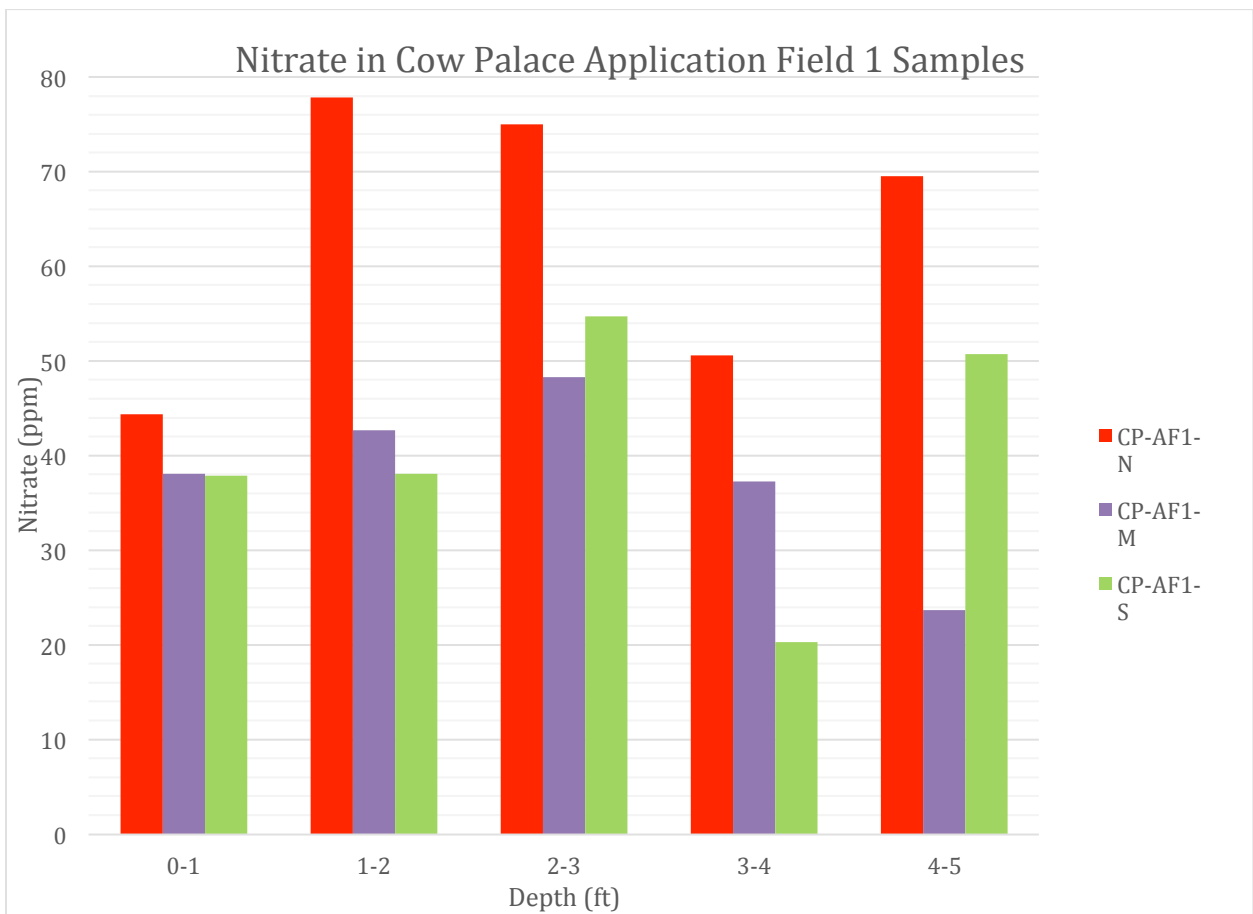
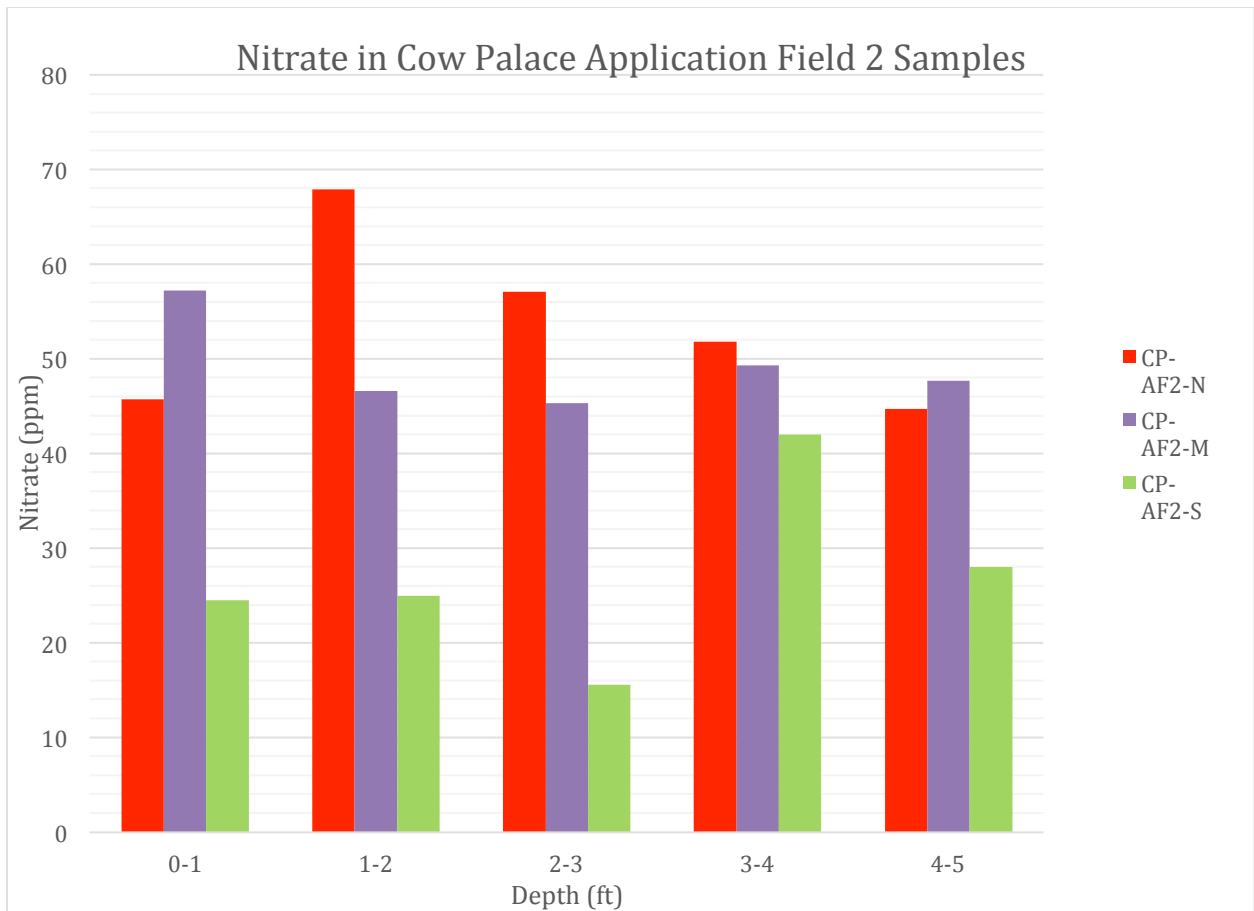
nitrate loading to groundwater from the Dairy. The nitrate concentrations measured in samples from 3 to 5 feet deep ranged from 2.2 ppm to 137 ppm, and averaged approximately 46 ppm. The graphs below depict nitrate concentrations in samples collected from the Cow Palace application fields, and Exhibit D contains graphs depicting nitrate, ammonium, and total nitrogen concentrations measured in these fields.

139. The nitrate concentrations observed in these deeper zones are of particular concern when one considers the well-documented moderate to well-drained soils underlying the Cow Palace fields, the fact that irrigated crop fields are a source of recharge to underlying aquifers, and the fact that nitrate is highly mobile and susceptible to leaching loss to groundwater in the absence of attenuating mechanisms such as plant uptake and soil adsorption.

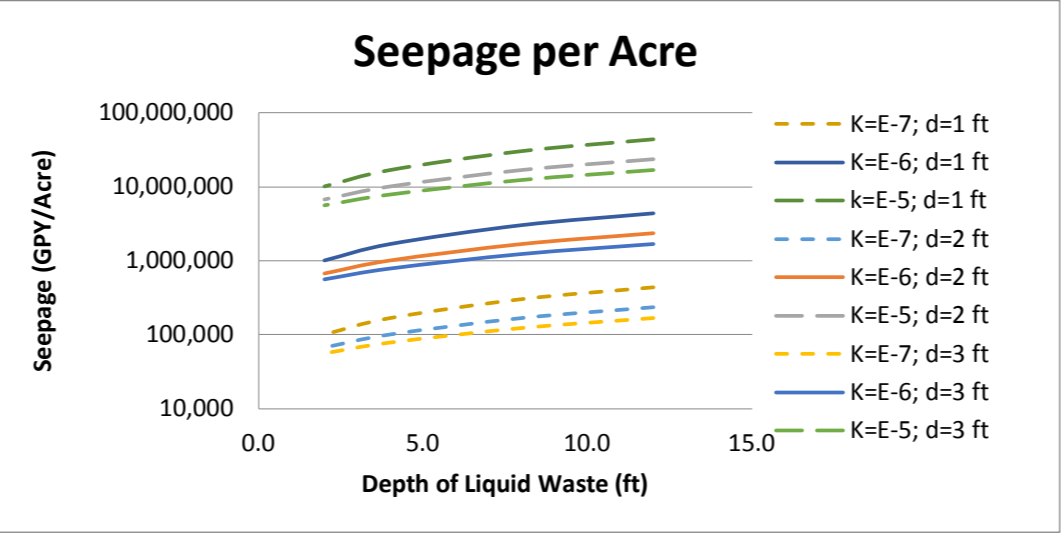
Seepage (q) from self sealed lagoon per unit area

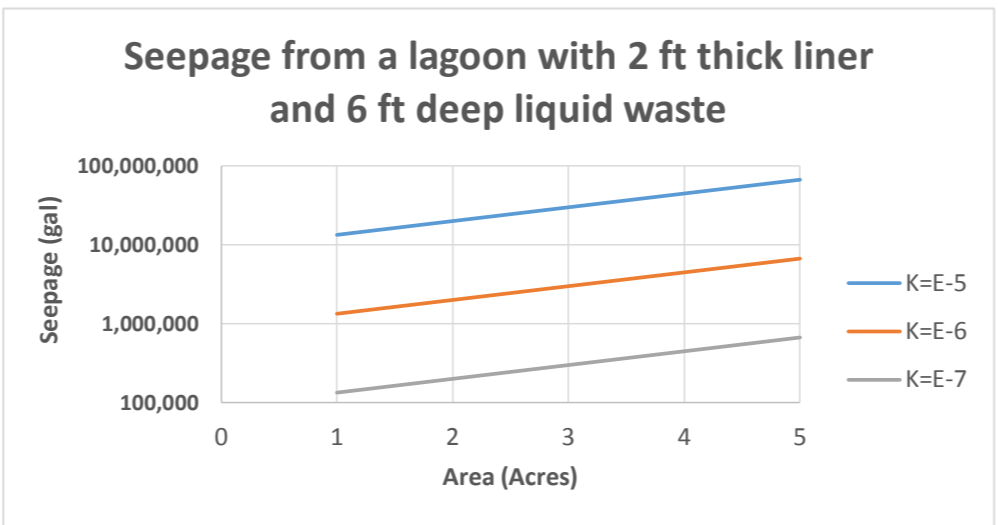
Seepage from a lagoon with a 2 ft thick liner
